## Specific Site Assessment for Coal Combustion Waste Impoundments at Minnkota Power Cooperative Milton R. Young Station

Center, North Dakota

June 2011  
Project 092884

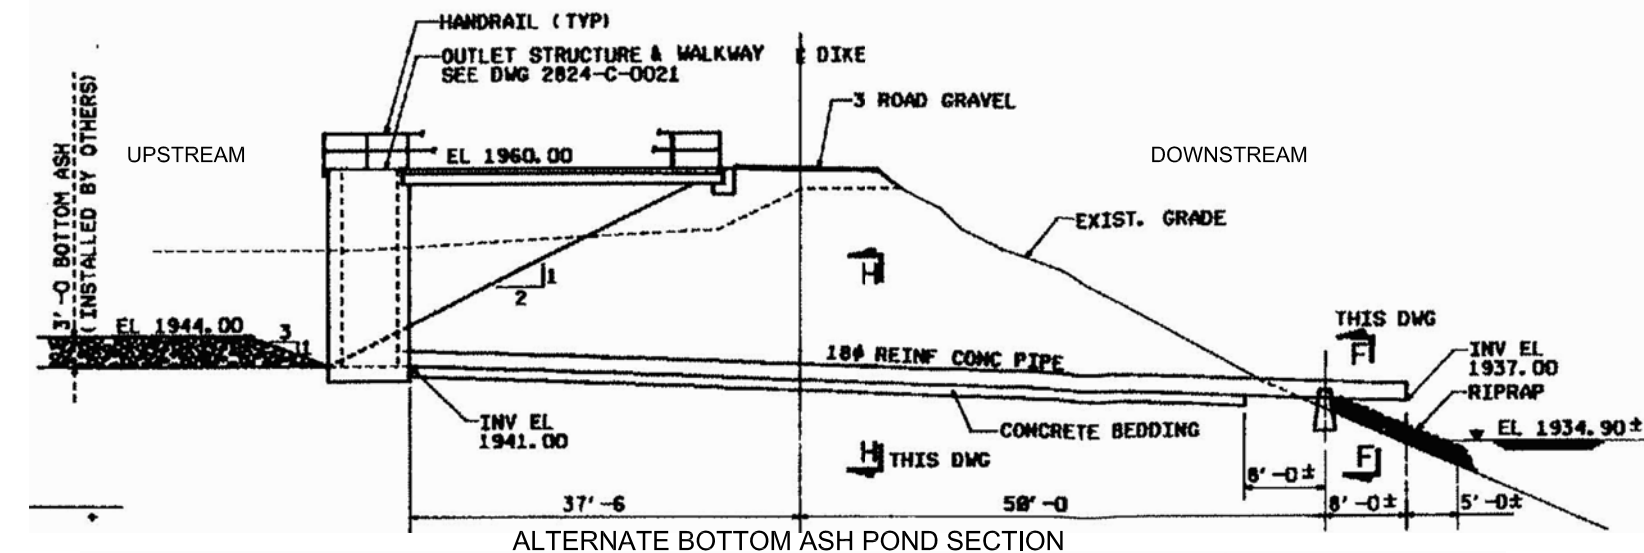
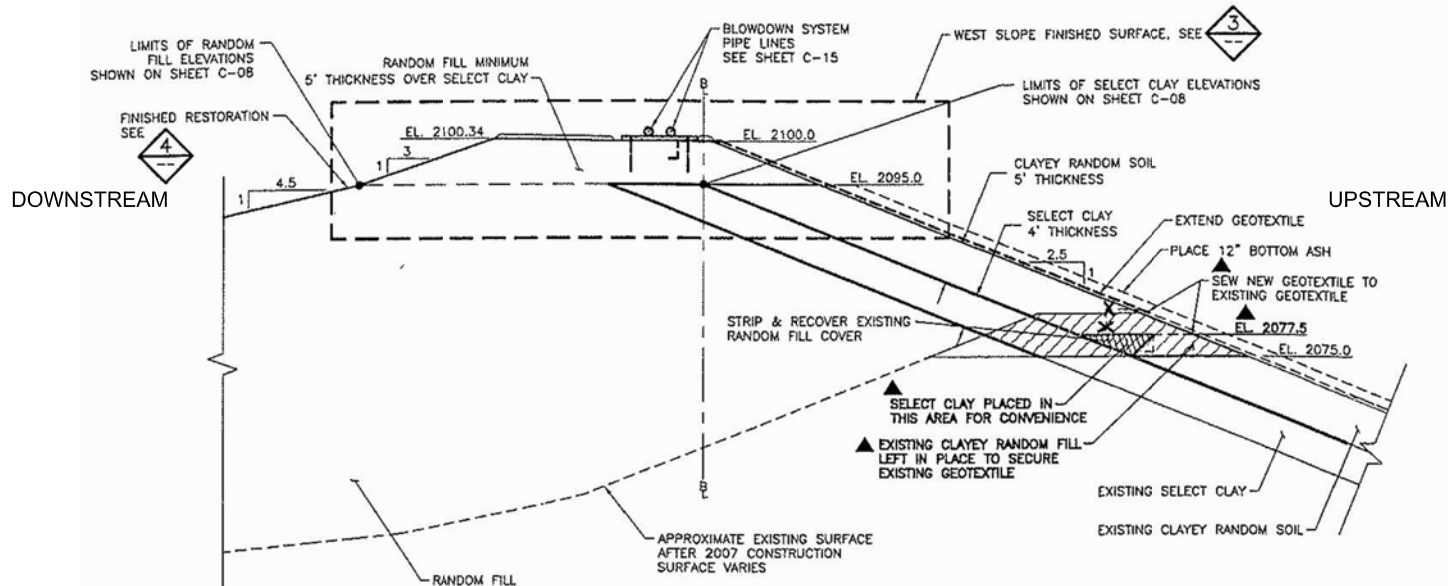
1. ALTERNATE BOTTOM ASH POND SECTION PREPARED BY EBASCO SERVICES INC. DATED 1984, REVISED.
2. CELL 1/CELL 2 SECTION PREPARED BY BARR ENGINEERING TITLED "PHASE III - CELL 2 LINER SECTIONS" RECORD DRAWING DATED 12/22/08.
